AD-A144 669 NATIONAL PROGRAM FOR INSPECTION OF NON-FEDERAL DAMS NEW 1/1  
BRITAIN RESERVOIR. (U) CORPS OF ENGINEERS WALTHAM MA  
NEW ENGLAND DIV AUG 79

US ARMY ENGINEER DIV. NEW ENGLAND CORPS OF ENGINEERS WALTHAM, MASS.	NATIONAL PROGRAM OF INSPECTION OF NON-FED DAMS		NEW BRITAIN RESERVOIR DAM ROARING BROOK	WOLCOTT CONNECTICUT	DATE <u>MARCH 79</u> CE # <u>27660 KB</u> PAGE <u>viii</u>
	CAHN ENGINEERS INC. WALLINGFORD, CONN. ENGINEER

## PHASE I INSPECTION REPORT

### NEW BRITAIN RESERVOIR DAM

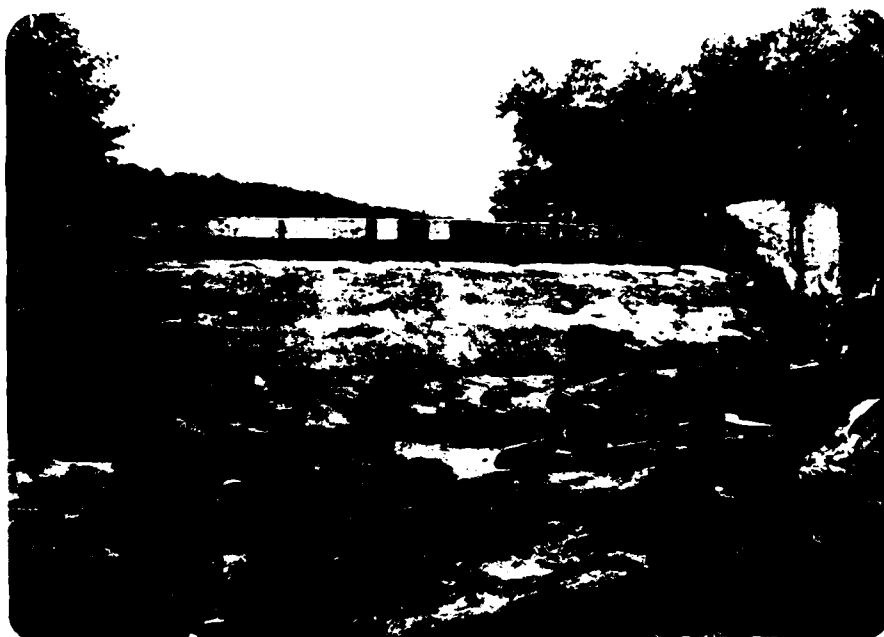
The inspections disclosed considerable damage to the spillway. The spillway weir had cracks, exposed aggregate on the downstream face and erosion of concrete at the base of the weir (Photo 12). Cracking and spalling of the concrete with lime deposits and wet areas were observed on both training walls (Photos 9 and 10). Some cracks were large and probably extended the width of the concrete to the bedrock abutment.

PHOTO 12 - Spillway discharge channel and stop-planks. Note cracks in weir crest and deterioration of concrete at base of weir (July, 1979).
